INDIAN BROOK RESERVOIR  
WESTCHESTER COUNTY  
NEW YORK  
INVENTORY NO 44

PHASE I INSPECTION REPORT  
NATIONAL DAM SAFETY PROGRAM.

Name of Dam Indian Brook Reservoir NY44

State Located New York  
County Located Westchester  
Stream Indian Brook River  
Date of Inspection July 26, 1978

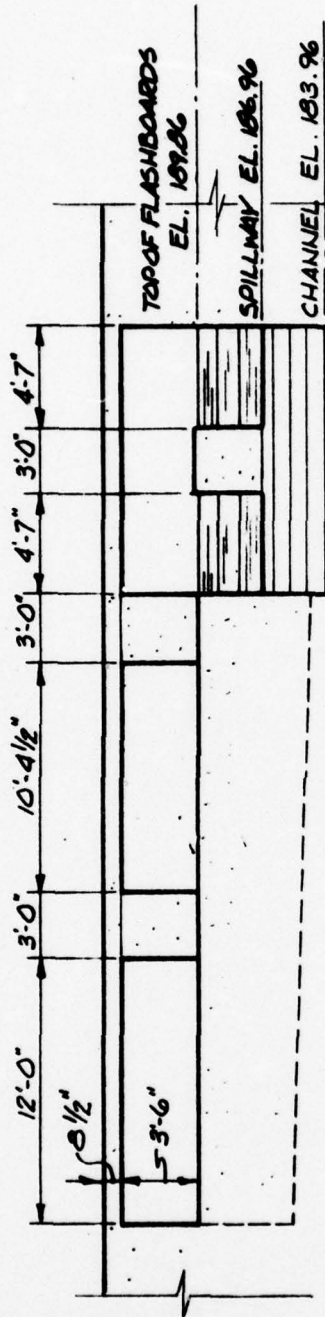
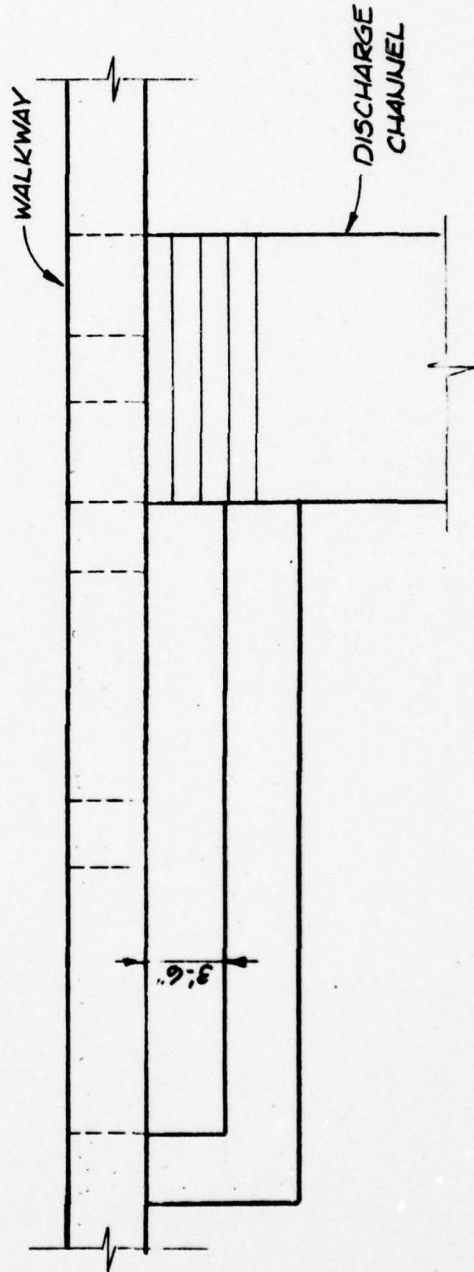
# SPILLWAY CHANNEL

Since no drawings on the dam were available, the spillway was measured in the field. A number of photographs of the spillway were taken as shown in Photographs 6 through 9. Flashboards were in place at the time of inspection. A gravity concrete block which restrains the flashboards has been displaced. Spalling concrete in the back face of the sill is shown in Photographs 8 and 9. The spillway channel is in good condition but is very small. Measurements were taken at a number of sections of the spillway chute. A lower spillway weir is located next to the stilling basin as shown in Photograph 11. Structurally, this appears to be in good condition.

The spillway's capacity is seriously inadequate and the dam was known to be topped previously. It is recommended that immediately, the owner take action so that in periods of unusually high runoff, the owner will provide around-the-clock surveillance and have a contingency plan in the event of overtopping. The flashboards should be removed immediately. Further improvements should not only improve the spillway capacity but include additional freeboard. Removal of the flashboards and increasing the spillway capacity would be adequate. Increasing the spillway capacity without removal of the flashboard is considered inadequate. Until the owner has significantly reduced on-going seepage and increased the spillway capacity, it is strongly recommended that the reservoir be kept at a safe level. Further studies should be made to make this determination. The drainage area of the reservoir should also be measured to confirm the figures used herein.
